**MALIBU  
REBUILDS**

**CITY OF MALIBU COMMUNITY MEETING SERIES**

**BIG ROCK, CALLE DEL BARCO NEIGHBORHOODS**

# BIG ROCK MESA

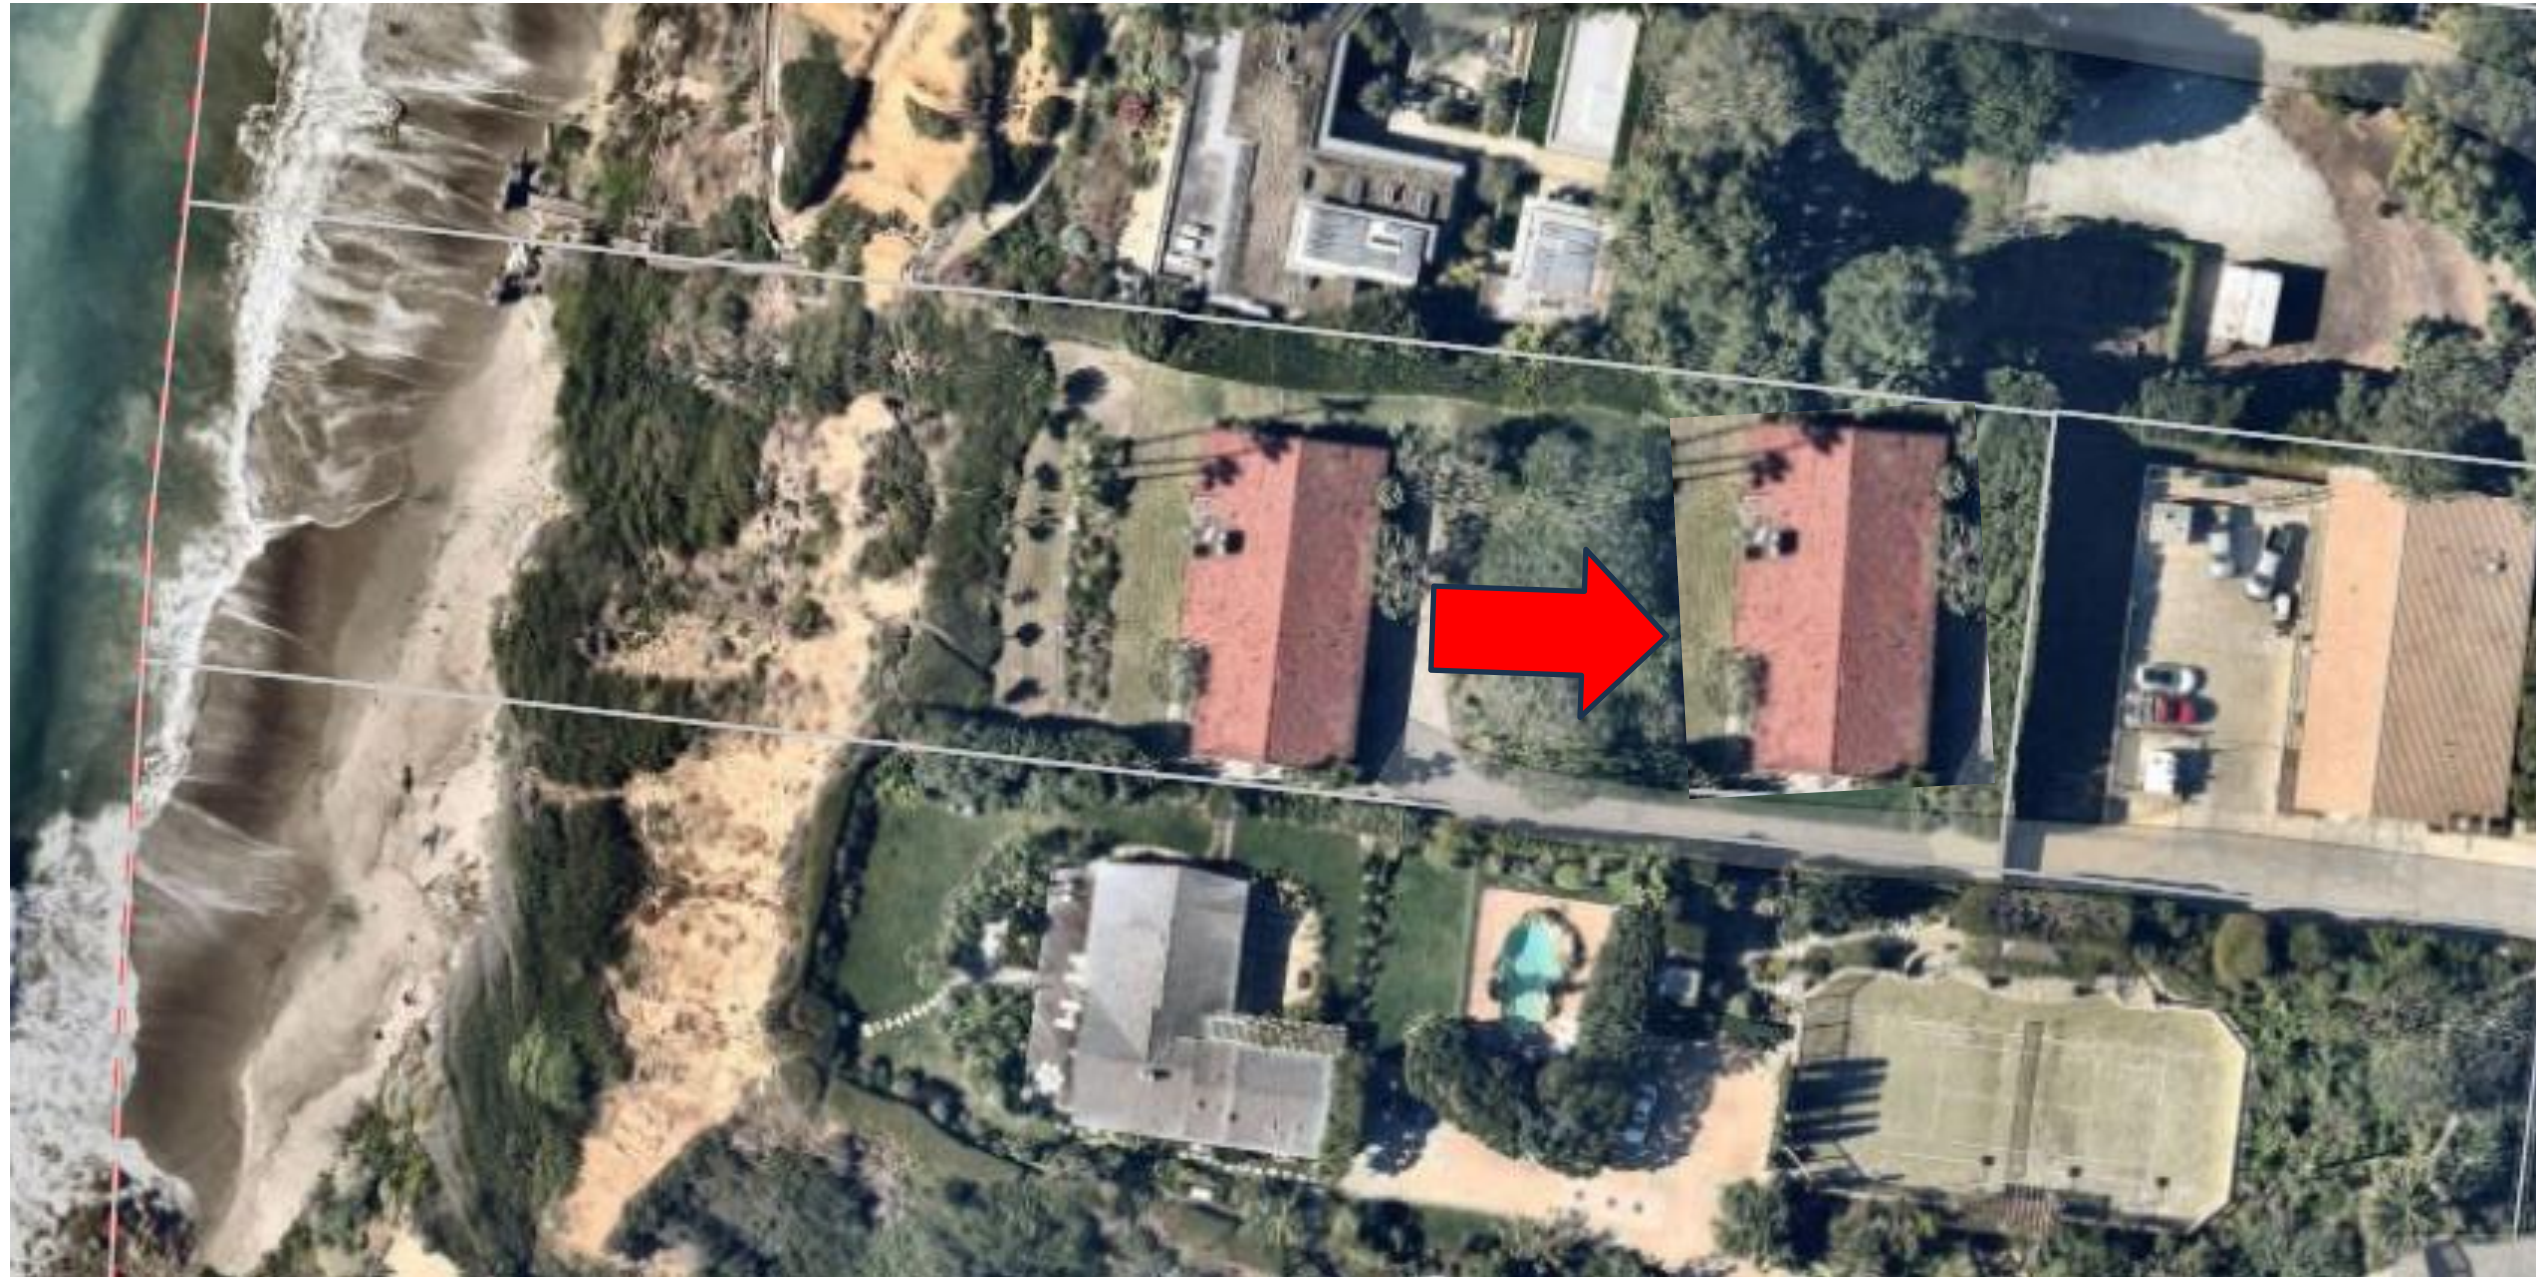
# SUBSTANTIAL RELOCATION

- Substantial relocation of existing homes will be considered (DMW\*)
- Geotechnical and Environmental Health pre-screen of PV\* to identify constraints
- Multi-Parcel geotechnical reports are acceptable
- Multi-Parcel topographic surveys are acceptable

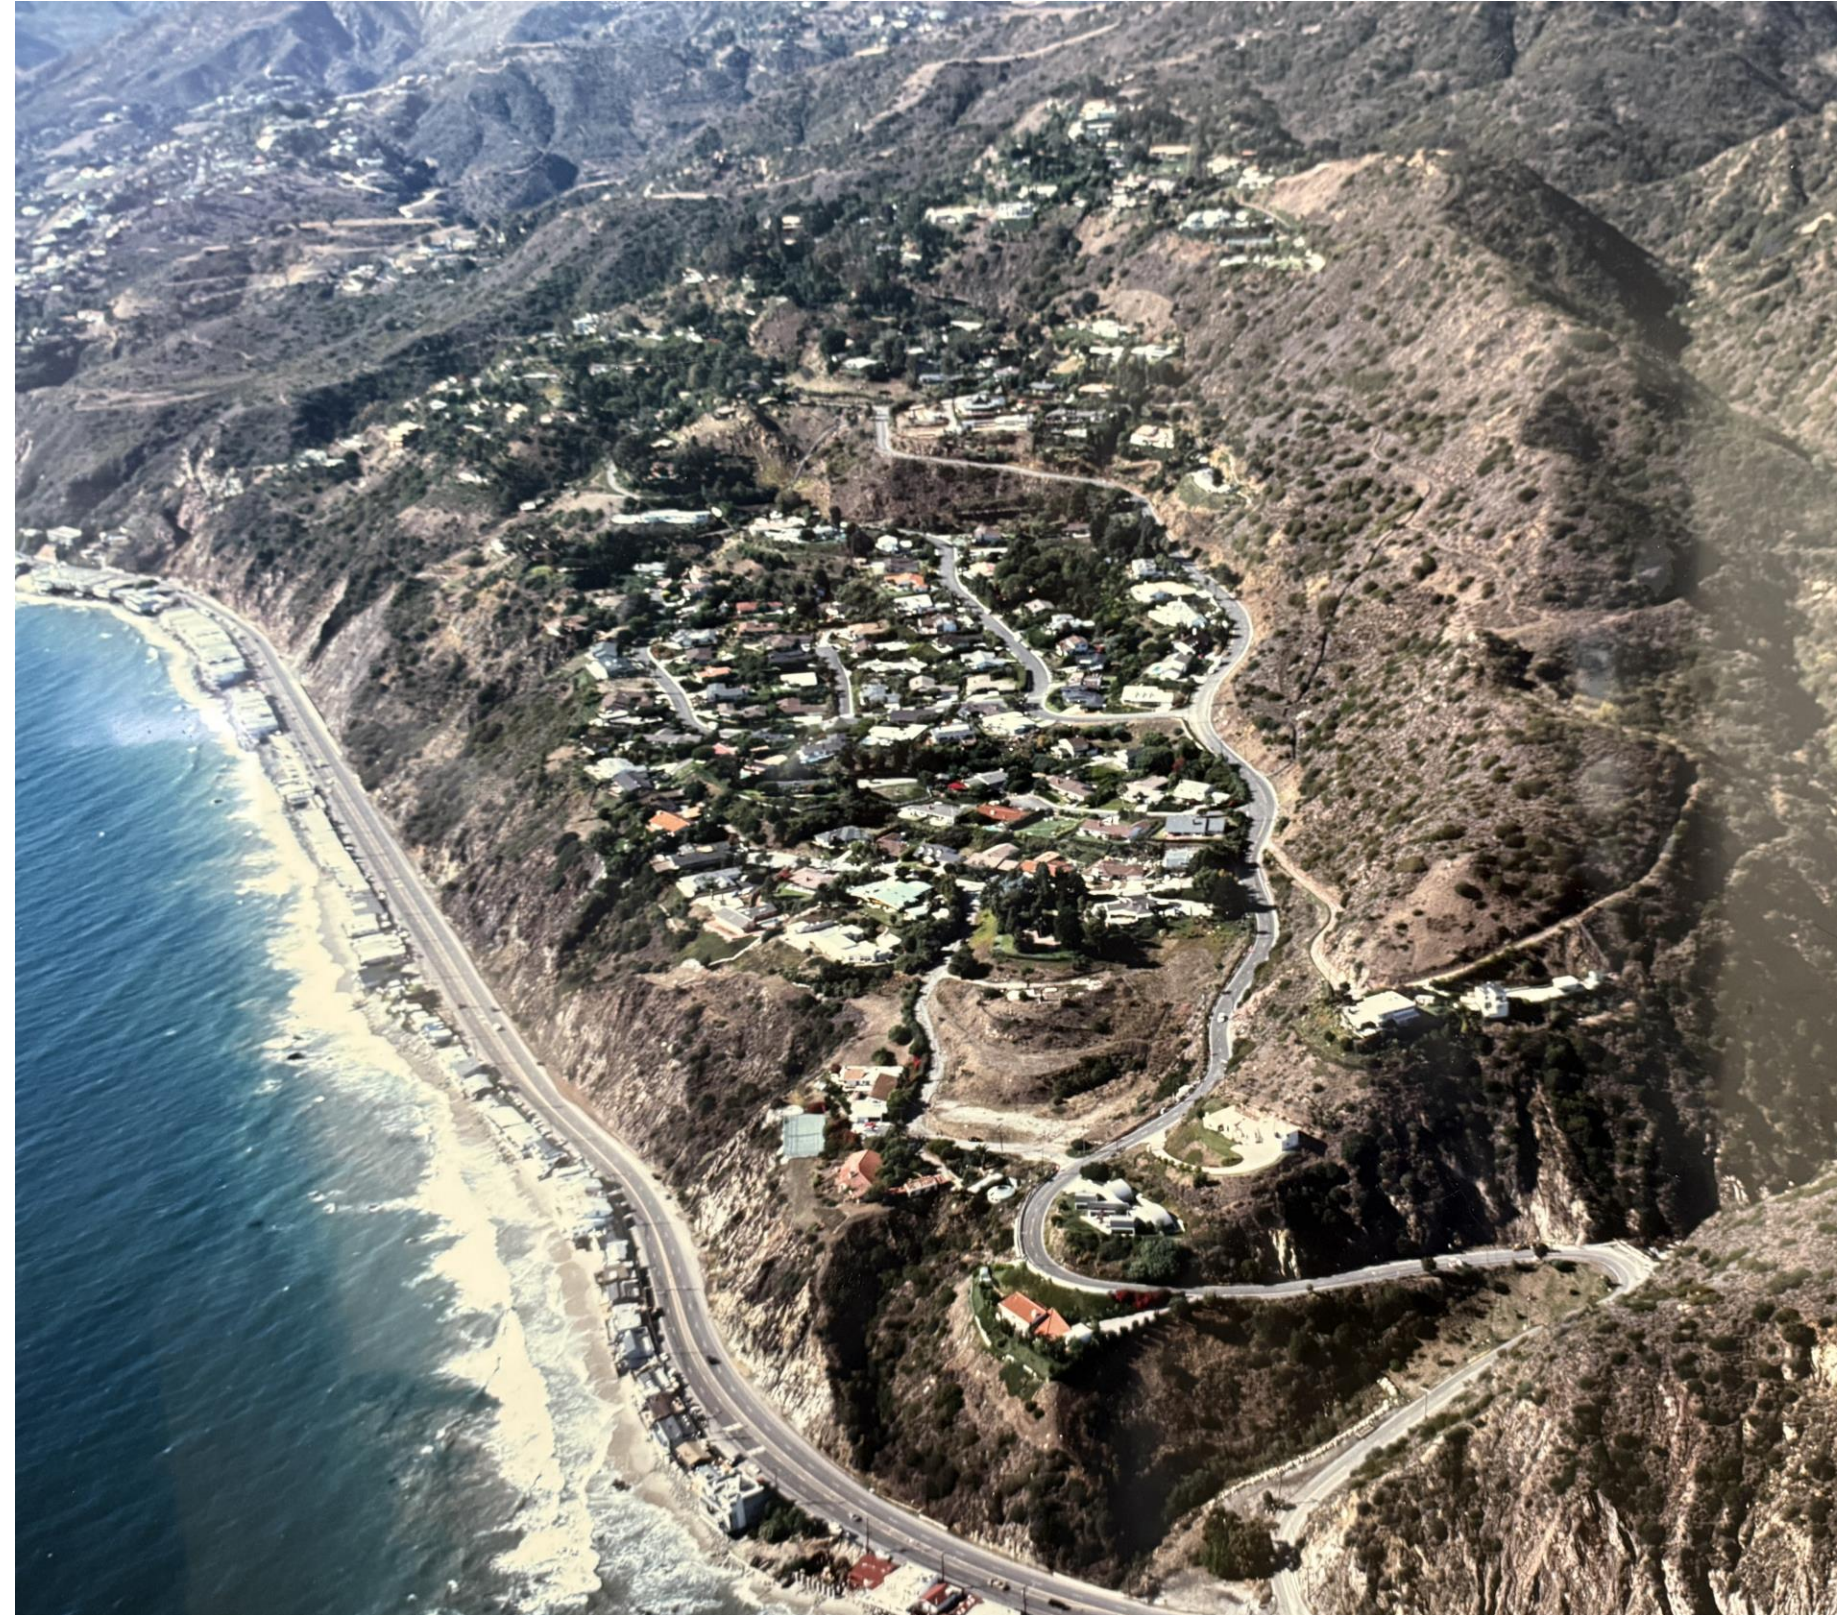
# BIG ROCK MESA LANDSLIDE

- **Big Rock Mesa Landslide**
  - Reactivated 1983, moved several feet
  - County formed CI 2629 in 1983, Landslide Assessment District 1989, reauthorized 1998 (AD 98-1)
  - Some homes burned in the 1993 Malibu/Old Topanga Fire
  - 1992 Bing Yen & Associates, Inc. Report is most comprehensive study:
    - Prevailing FOS (1991) = 1.2 - 1.25 in most regions of the landslide
    - Maximum attainable FOS (w/sewering & dewatering) ~1.4
    - "Western Extension" stability dependent on main BRM stability

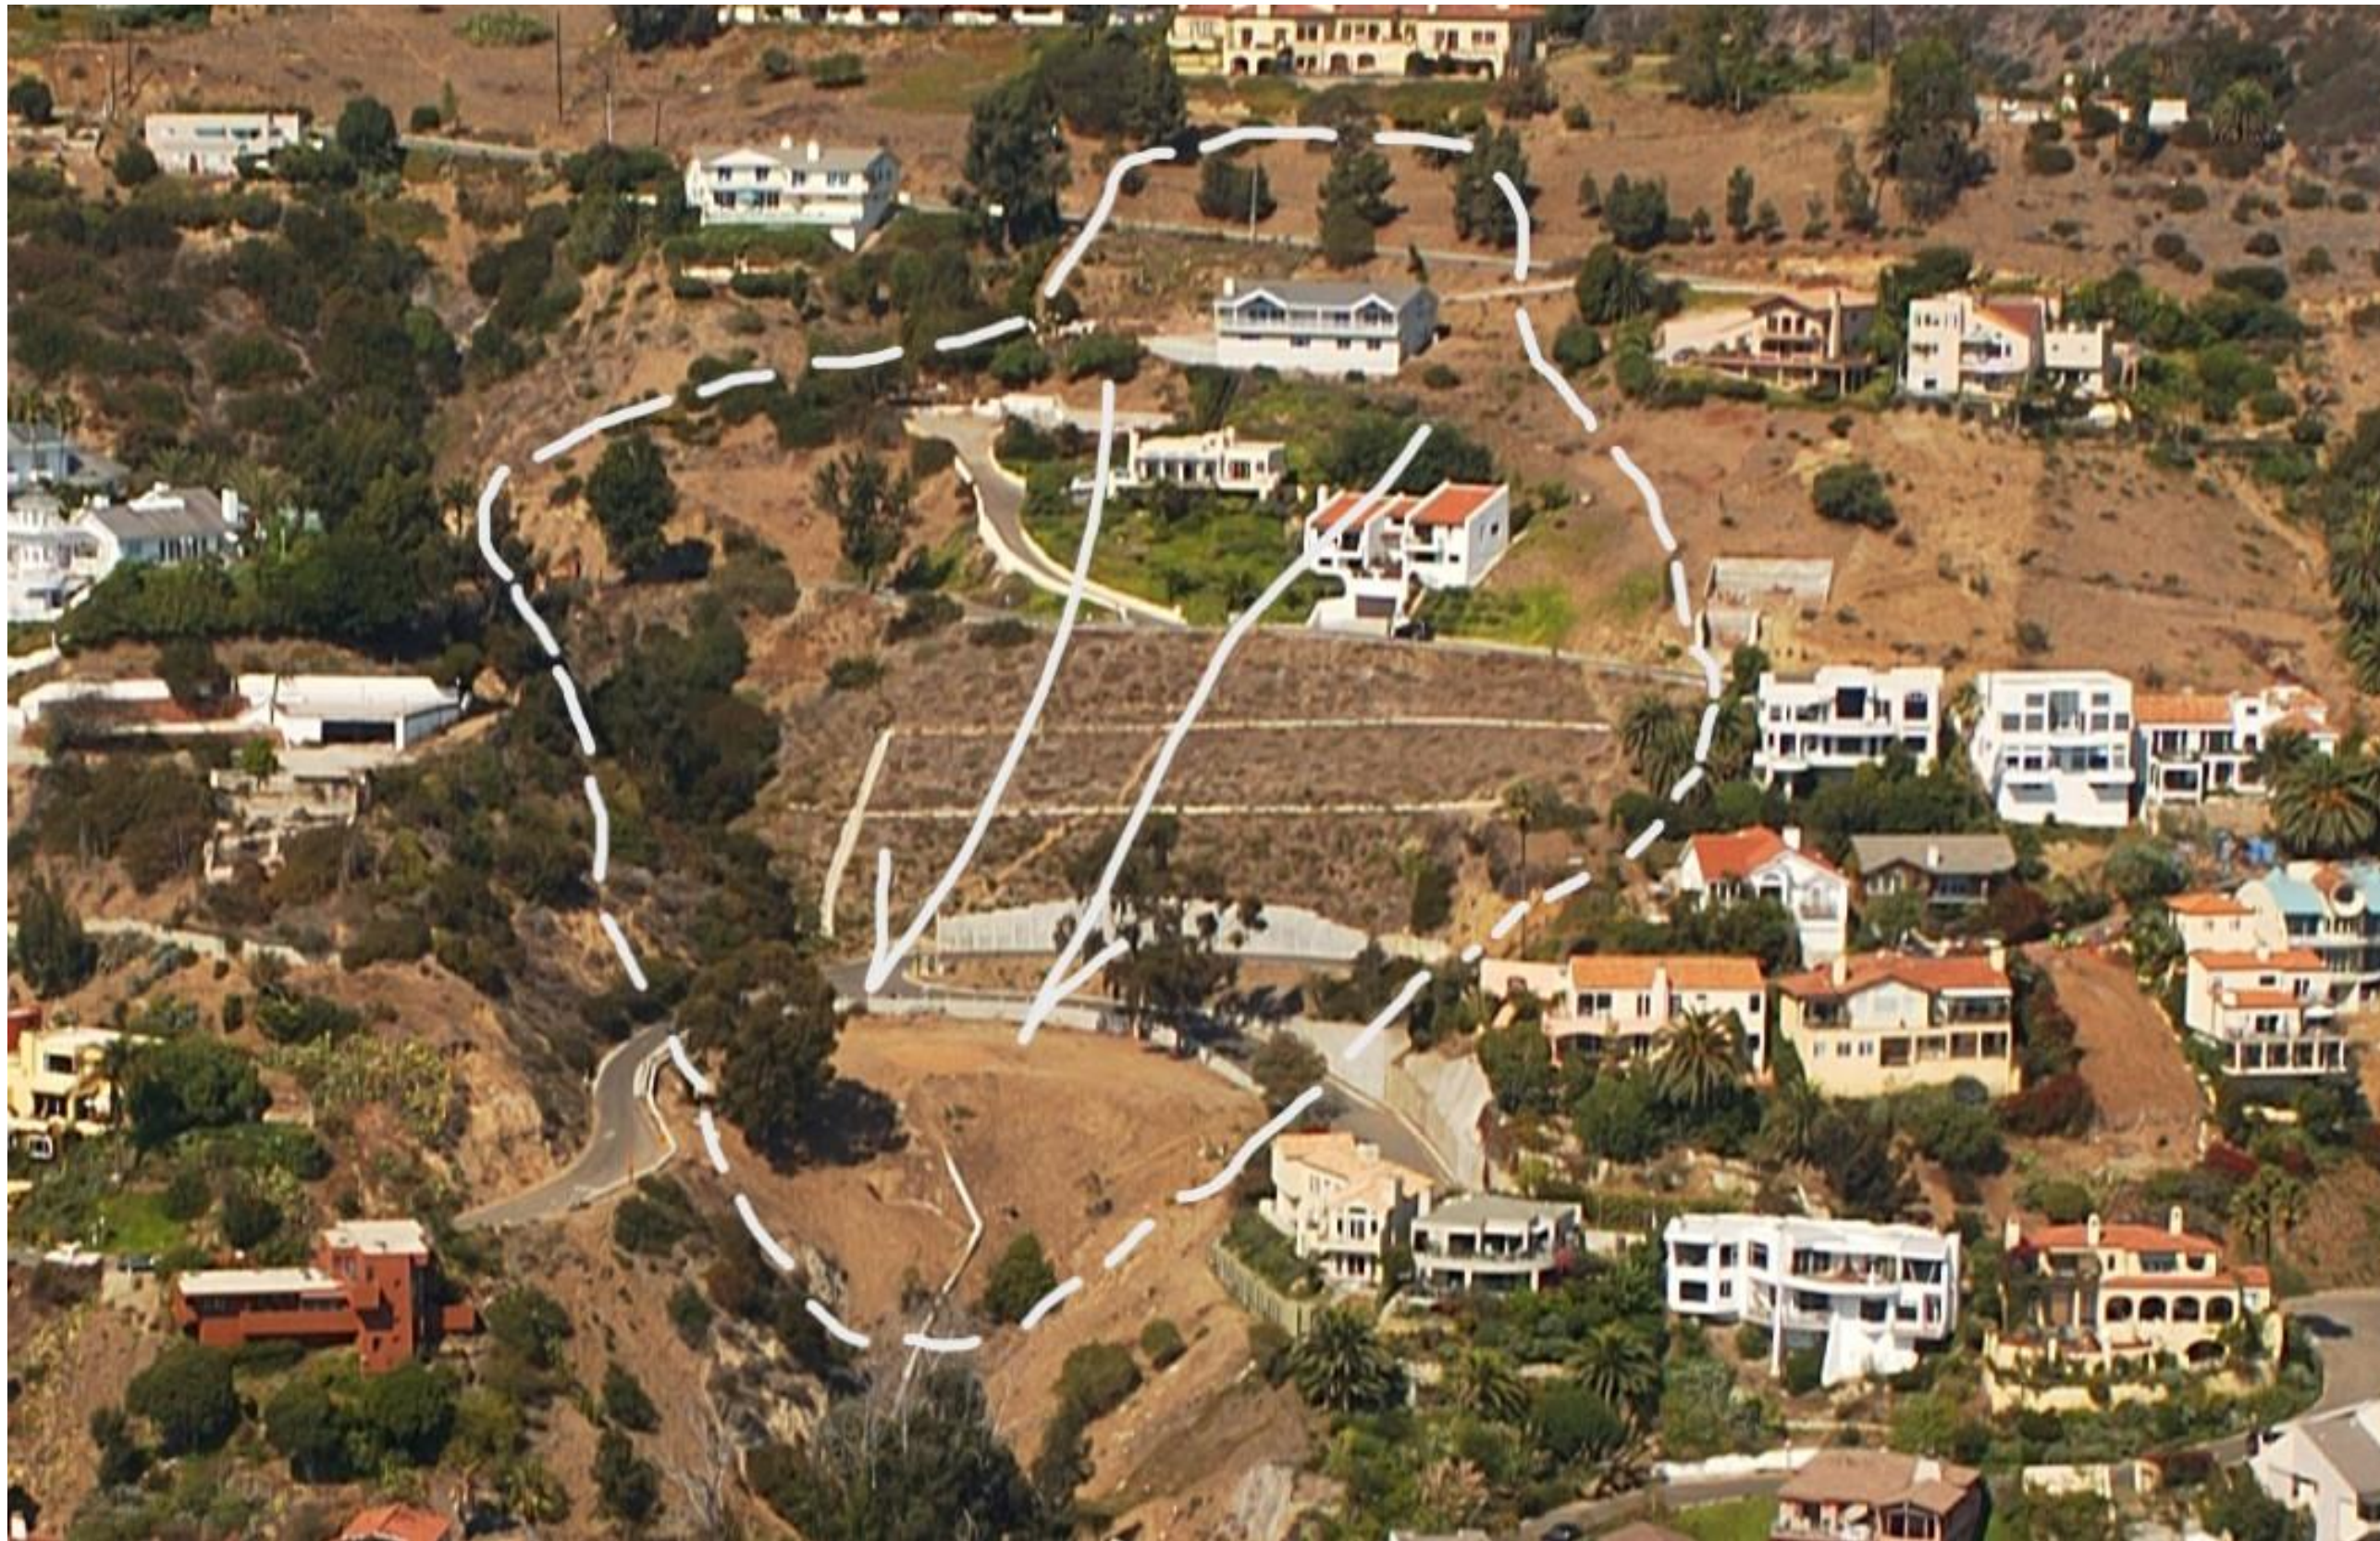
# CALLE DEL BARCO LANDSLIDE

- **Calle Del Barco Landslide**
  - Reactivated 1978 between Rambla Orienta and Calle Del Barco
  - County Improvement District (GHAD) mitigation measures included soldier piles and dewatering facilities
  - February 1998 Landslide and 1999-2000 "Access Restoration Project"
  - Landslide Assessment District reauthorized May 1998 (AD 98-2)
  - Larger/deeper ancient landslide creeps (wettest years or consecutive wet years)
